HOME REPORT

LOCHDHU GATE HOUSE
LOCHDHU
NAIRN
IV12 5PA

Energy Performance Certificate (EPC)

LOCHDHU GATE HOUSE, LOCHDHU, NAIRN, IV12 5PA

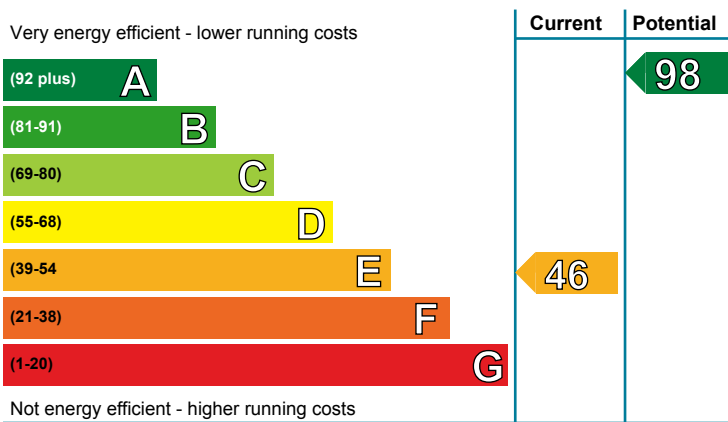
Energy Efficiency Rating

This graph shows the current efficiency of your home, taking into account both energy efficiency and fuel costs. The higher this rating, the lower your fuel bills are likely to be.

Your current rating is **band E (46)**. The average rating for EPCs in Scotland is **band D (61)**.

The potential rating shows the effect of undertaking all of the improvement measures listed within your recommendations report.

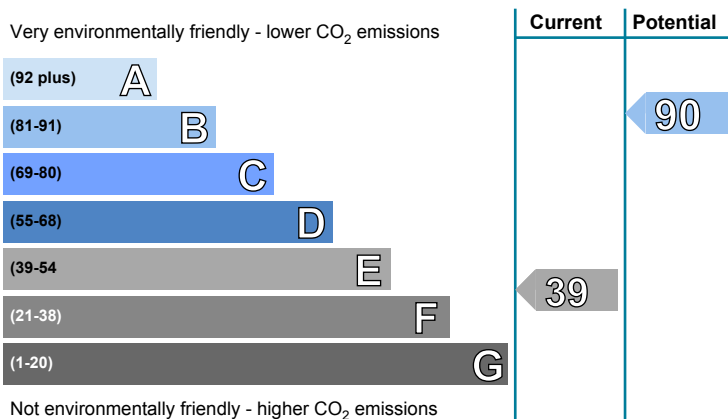
Environmental Impact (CO₂) Rating

This graph shows the effect of your home on the environment in terms of carbon dioxide (CO₂) emissions. The higher the rating, the less impact it has on the environment.

Your current rating is **band E (39)**. The average rating for EPCs in Scotland is **band D (59)**.

The potential rating shows the effect of undertaking all of the improvement measures listed within your recommendations report.

The average Scottish household produces about 6 tonnes of carbon dioxide every year. Based on this assessment, heating and lighting this home currently produces approximately 9.8 tonnes of carbon dioxide every year. Adopting recommendations in this report can reduce emissions and protect the environment. If you were to install all of these recommendations this could reduce emissions by 7.4 tonnes per year. You could reduce emissions even more by switching to renewable energy sources.
